Manhole Inspection Summary

Manhole # S13AA2002MH

Location Address: **2204 KEN OAK RD**

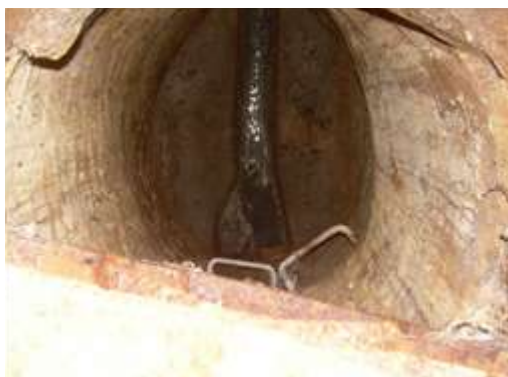
Top View

Surcharge ☒ **Evidence Of Surcharge** Depth: **1** (ft.) ☐ Active Surcharge Present

Evidence of surcharge - Bench debris.
Channel debris.

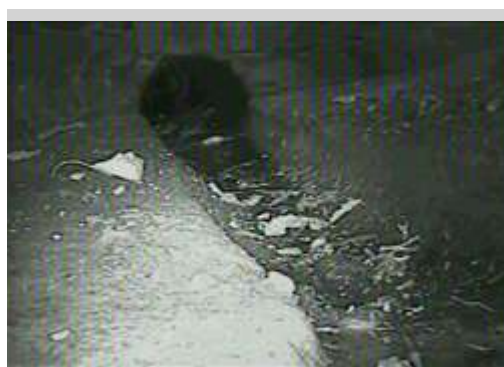
Defect

Condition: ☐ Sound ☐ Cracked ☐ Root Intrusion ☐ Loose Brick ☒ **Deteriorated**

Infiltration: ☐ None ☐ Joint ☐ Cracks ☒ **Mortar** ☐ Roots ☒ **Wall**

Bench and Channel debris. Barrel
deterioration and infiltration.

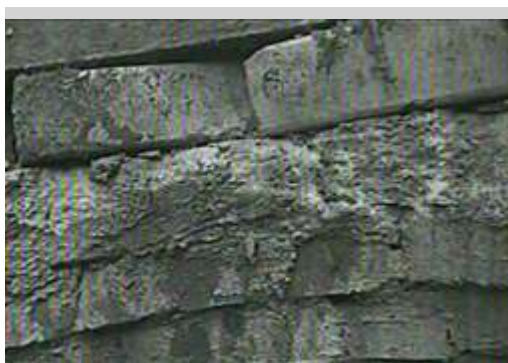
Defect

Condition: ☐ Sound ☐ Cracked ☒ **Root Intrusion** ☒ **Loose Brick** ☒ **Deteriorated**

Infiltration: ☐ None ☒ **Joint** ☐ Cracks ☒ **Mortar** ☐ Roots ☐ Wall

Adjustment deterioration, loose brick and
infiltration.

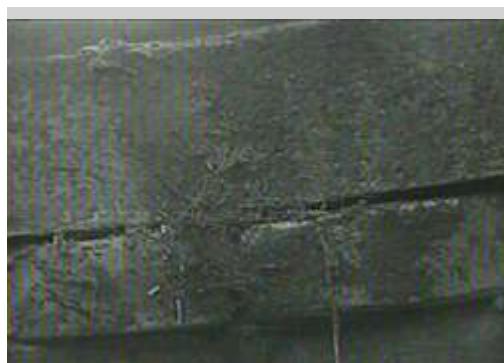
Defect

Frame Offset: **0** (in.) Condition: ☐ Sound ☐ Cracked ☒ **Leaks**

Frame leaks. Adjustment root intrusion
and infiltration.

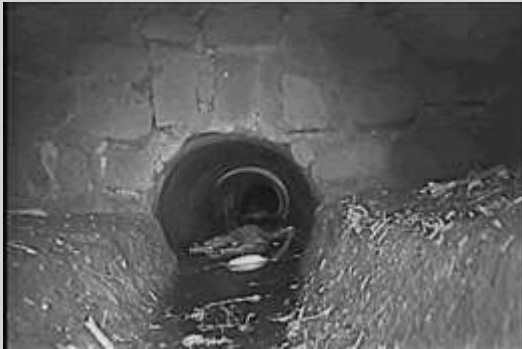
8 in. Circular Gravity Sewer Pipe Out @ 12 O'Clock

Barrel deterioration and infiltration.

Deposits: ☐ None ☐ Mud ☐ Sludge ☒ **Debris** ☐ Grease

Infiltration: **Evidence** Pipe Seal Cond: **Cracked**

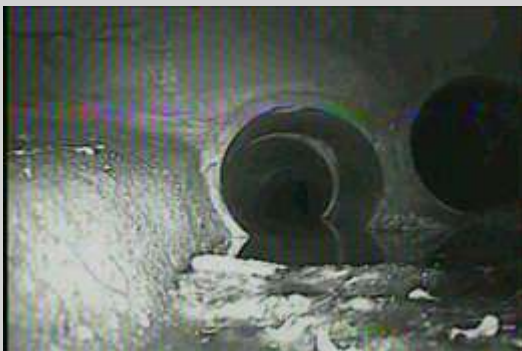
6 in. Circular Gravity Sewer Pipe In @ 6 O'Clock

Infiltration: **Evidence** Pipe Seal Cond: **Unknown**

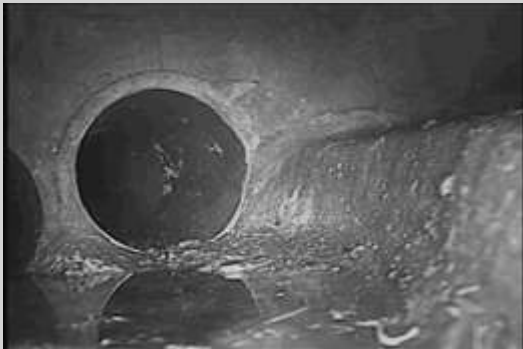
6 in. Circular Gravity Sewer
Pipe In @ 7 O'Clock

Infiltration: **Evidence** Pipe Seal Cond: **Unknown**
